# Accelerated corrosion of zinc alloys exposed to ultraviolet light

E. A. Thompson<sup>1</sup> and T. D. Burleigh<sup>\*2</sup>

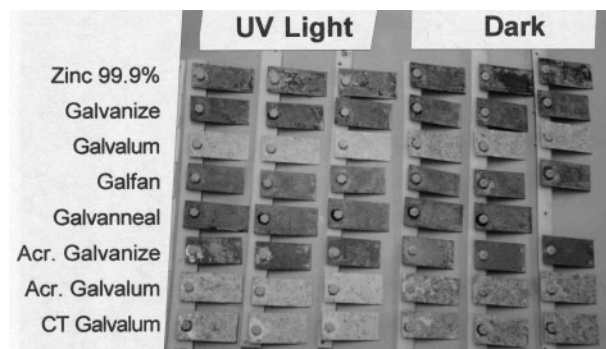
1 Triplicate zinc samples are shown after four months of immersion in water stream, both in UV light and in dark

lamp was ~2.5 cm. Both sides of the coupons were exposed to the UV light and the cut edges of each sample were not sealed. Every week or two weeks, the channels were drained for 1–2 h and rinsed with fresh water. At the end of the four month period, the racks were removed, rinsed and allowed to dry in the air (see Fig. 1). Each coupon was then carefully removed from the rack and weighed. The corrosion product was next removed using ammonium persulphate per ASTM-G1<sup>8</sup> and then these cleaned coupons were reweighed.

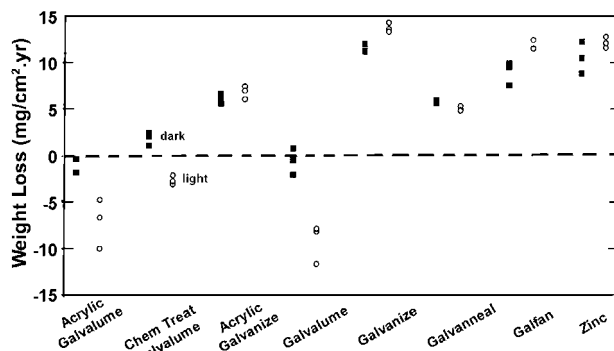
2 Weight loss (or gain) of zinc samples are shown before removal of corrosion products: solid black squares are control samples in dark, while hollow circles are samples exposed to UV light

Each coupon was weighed before the removal of the corrosion product. The change in weight per area during the four months was calculated for each coupon and the individual data points are plotted in Fig. 2. Positive

values are a weight loss, and negative values are a weight gain. The open circles are the weight change under the UV lamps, and the solid squares are the weight change in the 'dark'. The white corrosion product was more adherent on some samples than other samples. Localised corrosion (pitting) was the dominant form of corrosion during this fresh water immersion.

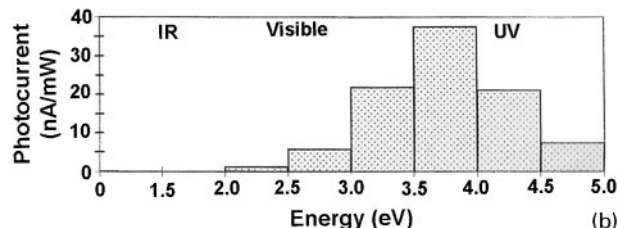
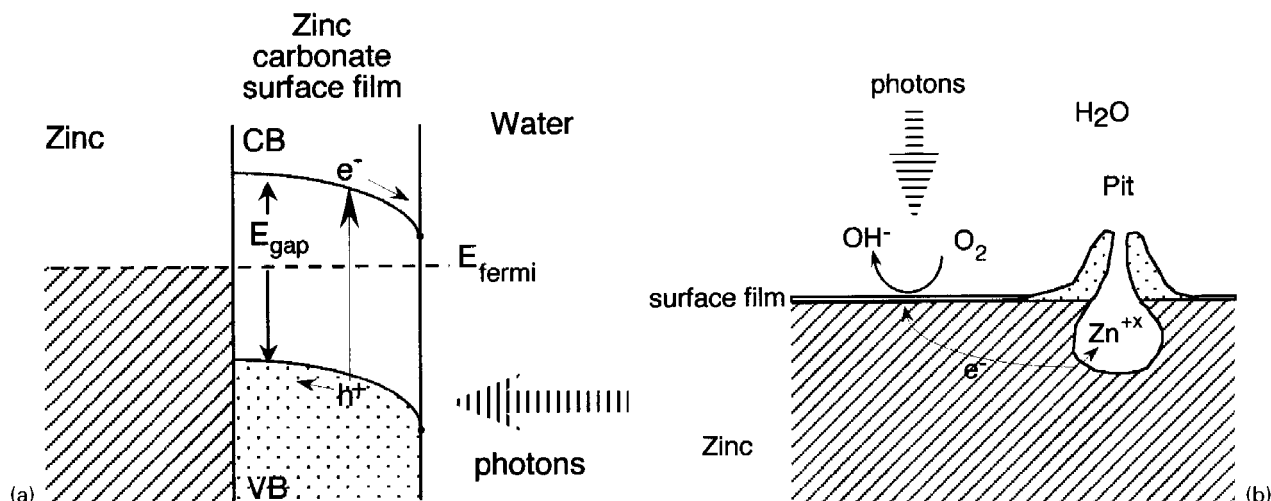
##### 5 Band bending schematic

a photons excite electrons into conduction band where they flow down to water interface; b electrons are replenished by pitting corrosion of zinc

Figure 5 illustrates the mechanism by which light lowers the dark current temporarily, but accelerates localised corrosion in the long run.<sup>7</sup> The photons excite an electron from the valence band to the conduction band, where it flows downhill to the electrolyte interface. The excess electrons at the electrolyte interface accelerate the cathodic reaction. This increased cathodic reaction increased the localised pitting corrosion of the zinc (Fig. 5*b*).<sup>7</sup>

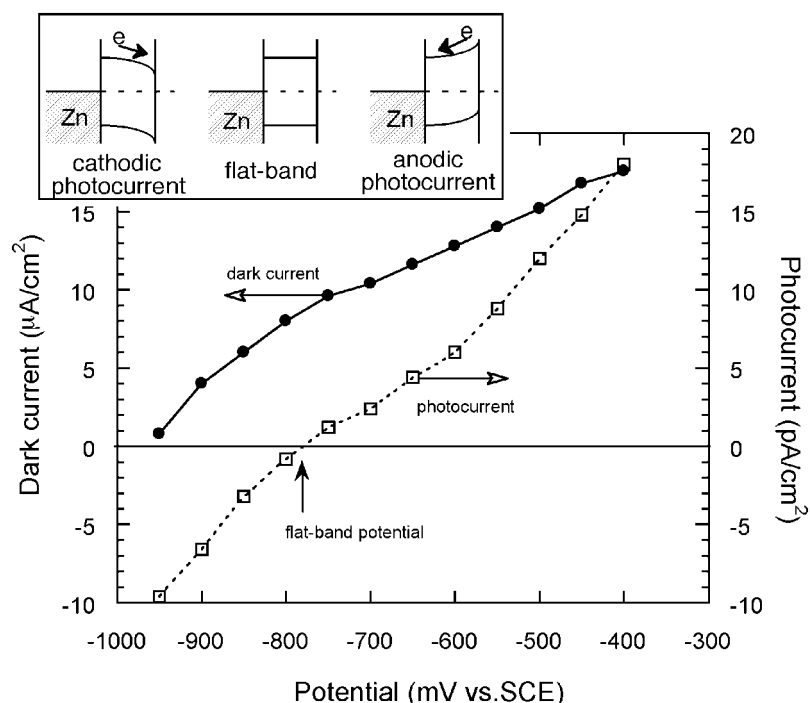
6 Flat band potential was measured by polarising zinc near its OCP in municipal tap water [about  $-950$  mV saturated calomel electrode (SCE)], and then stepping potential anodic in  $+50$  mV steps, and measuring dark current and photocurrent at each step: flat band potential is potential where photocurrent goes to zero, or goes from negative to positive

The flat band potential is the point where the applied potential results in zero photocurrent. A typical experimental curve is shown in Fig. 6 for the pure zinc. Starting at the open circuit potential, the potential was increased in +50 mV steps, and the corrosion current

(dark current) and the photocurrent were both measured at each step. The photocurrent was initially negative, and decreased in magnitude as the potential increased. At  $-800$  mV, the photocurrent became very small, and at higher potentials, the photocurrent changed signs and increased with potential. The flat band potential is the potential where the photocurrent extrapolates to zero, or changes from negative to positive.

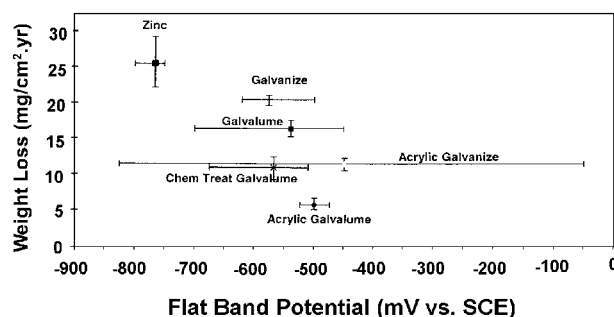
7 Measured flat band potentials versus corrosion rates for zinc and Al-Zn samples show downward trend

Figure 7 shows the range of flat band potentials for samples measured, versus the range of weight loss in the dark. There is good reproducibility for the measured flat band potentials for zinc, galvanise, and acrylic galvanise. Poor reproducibility was seen in the acrylic galvanise. There was no significant change in the flat

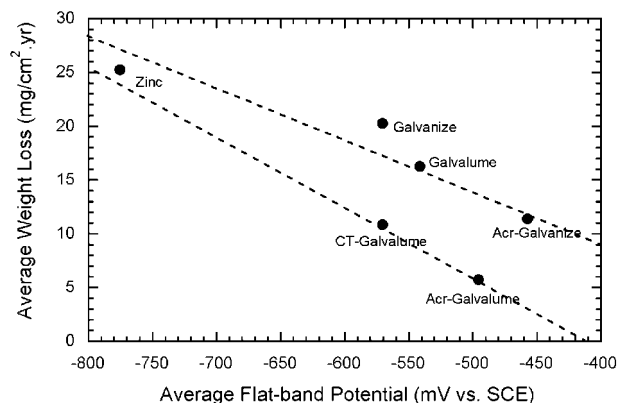
**8 Average flat band potential and average corrosion rates show trend that more positive flat band potentials correspond to lower corrosion rates**

The average values for the ranges shown in Fig. 7 are replotted in Fig. 8 for the six samples. As the flat band potential increases to more positive potentials, the weight loss decreases. In other words, the alloy with the more positive flat band potential corroded less. Although this comparison is intriguing, it does not take into account the changing corrosion product composition for the different alloys. However if the zinc carbonates were the identical, a suggested way to improve the pitting resistance of a zinc alloy would be to raise the flat band potential. The flat band potential can be shifted to the right (more positive) by doping the carbonate more *p* type. The challenge, therefore, is to alloy with an element that has a valence of +1 and that can form a solid solution with zinc, such as lithium. This *p* type doping to increase pitting resistance of zinc is the opposite of the Burleigh's previous work which found that *n* type doping increased the erosion-corrosion resistance of copper-nickel alloys.<sup>10</sup> Therefore the benefits of *n* type doping versus *p* type doping of
